REPORT OF THE BOARD OF INQUIRY INTO THE HELDERBERG AIR DISASTER

REPORT OF THE BOARD OF INQUIRY INTO THE LOSS OF
SOUTH AFRICAN AIRWAYS BOEING 747 - 244B COMBI AIRCRAFT "HELDERBERG"
IN THE INDIAN OCEAN ON NOVEMBER 28TH 1987

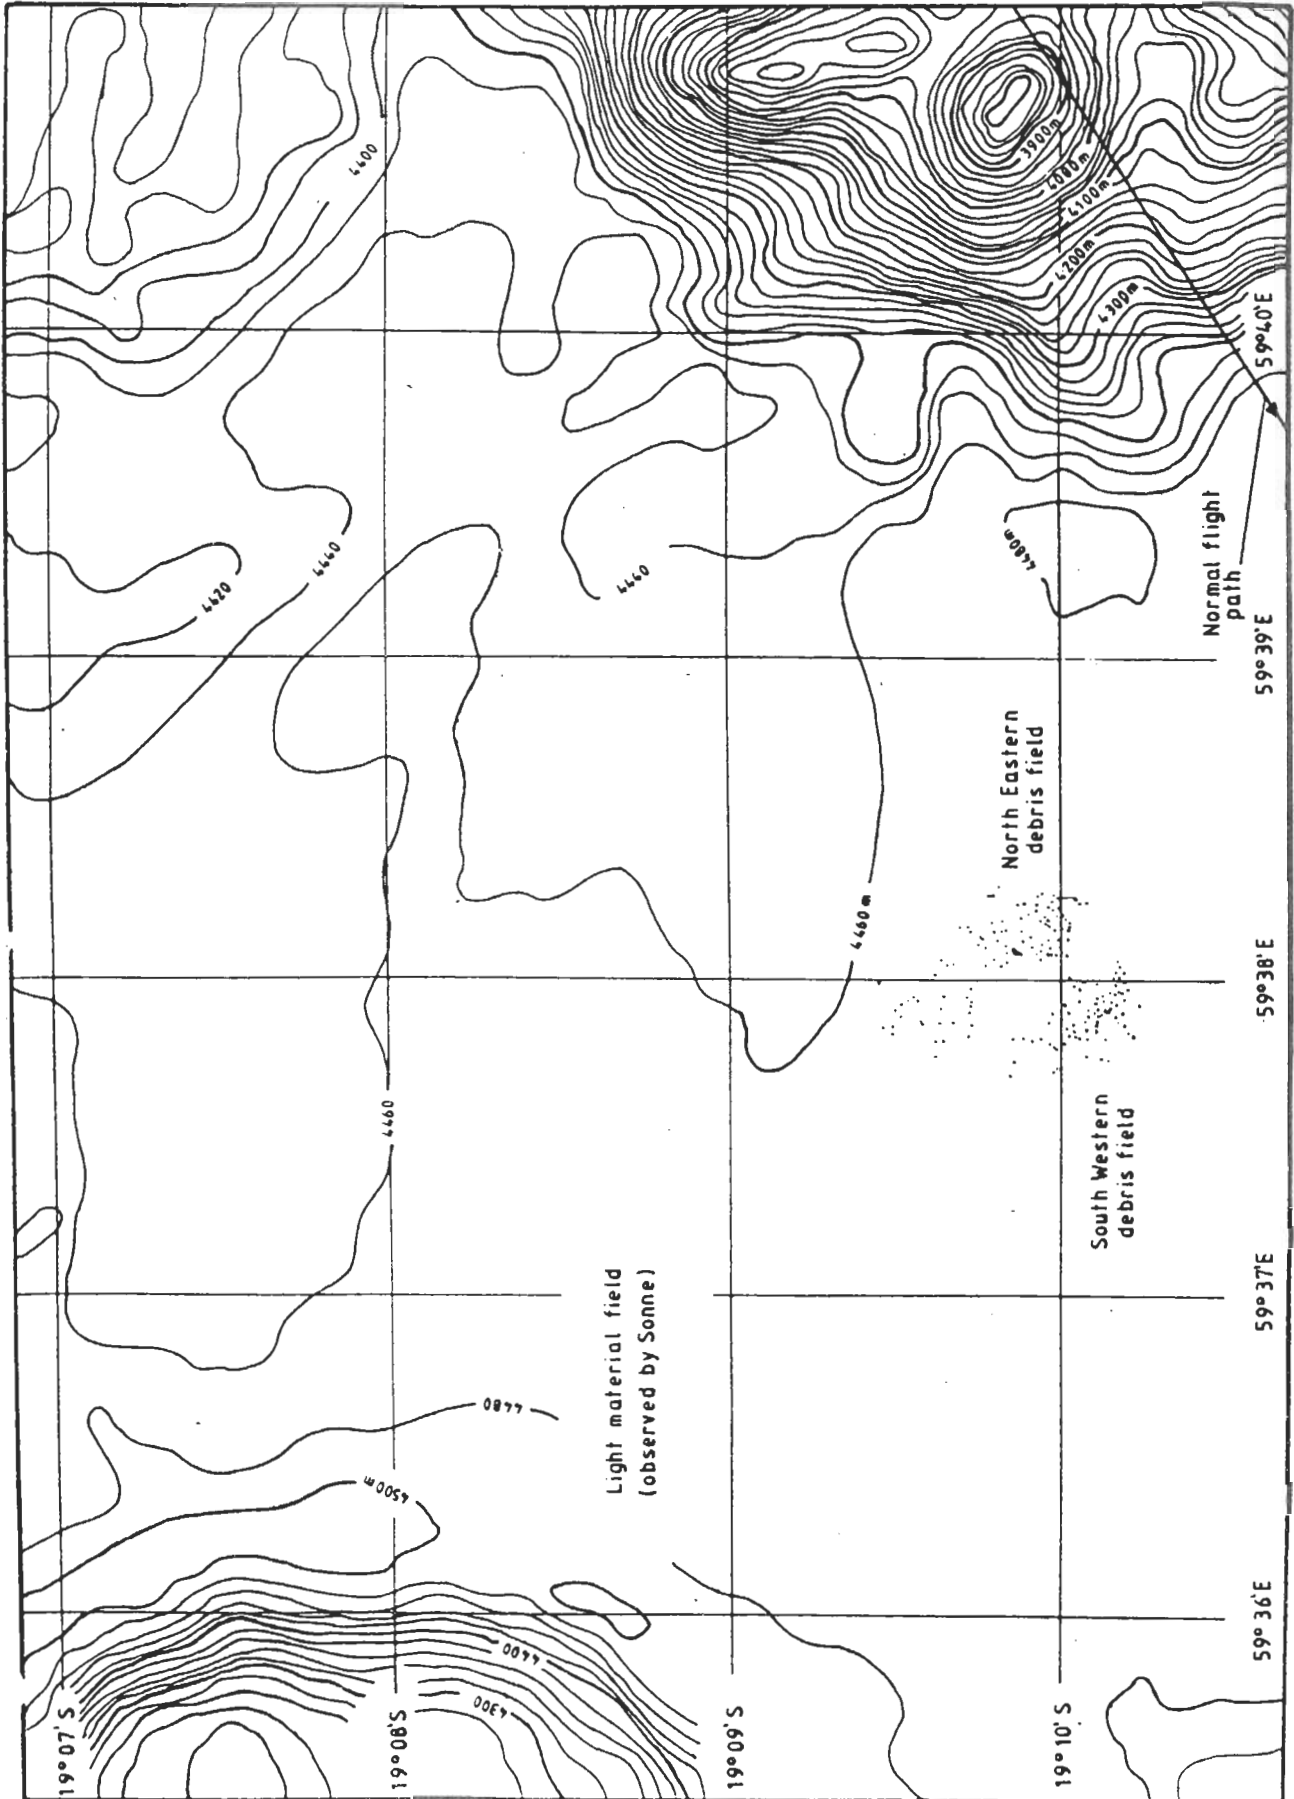
Figure 1

2
Main debris field

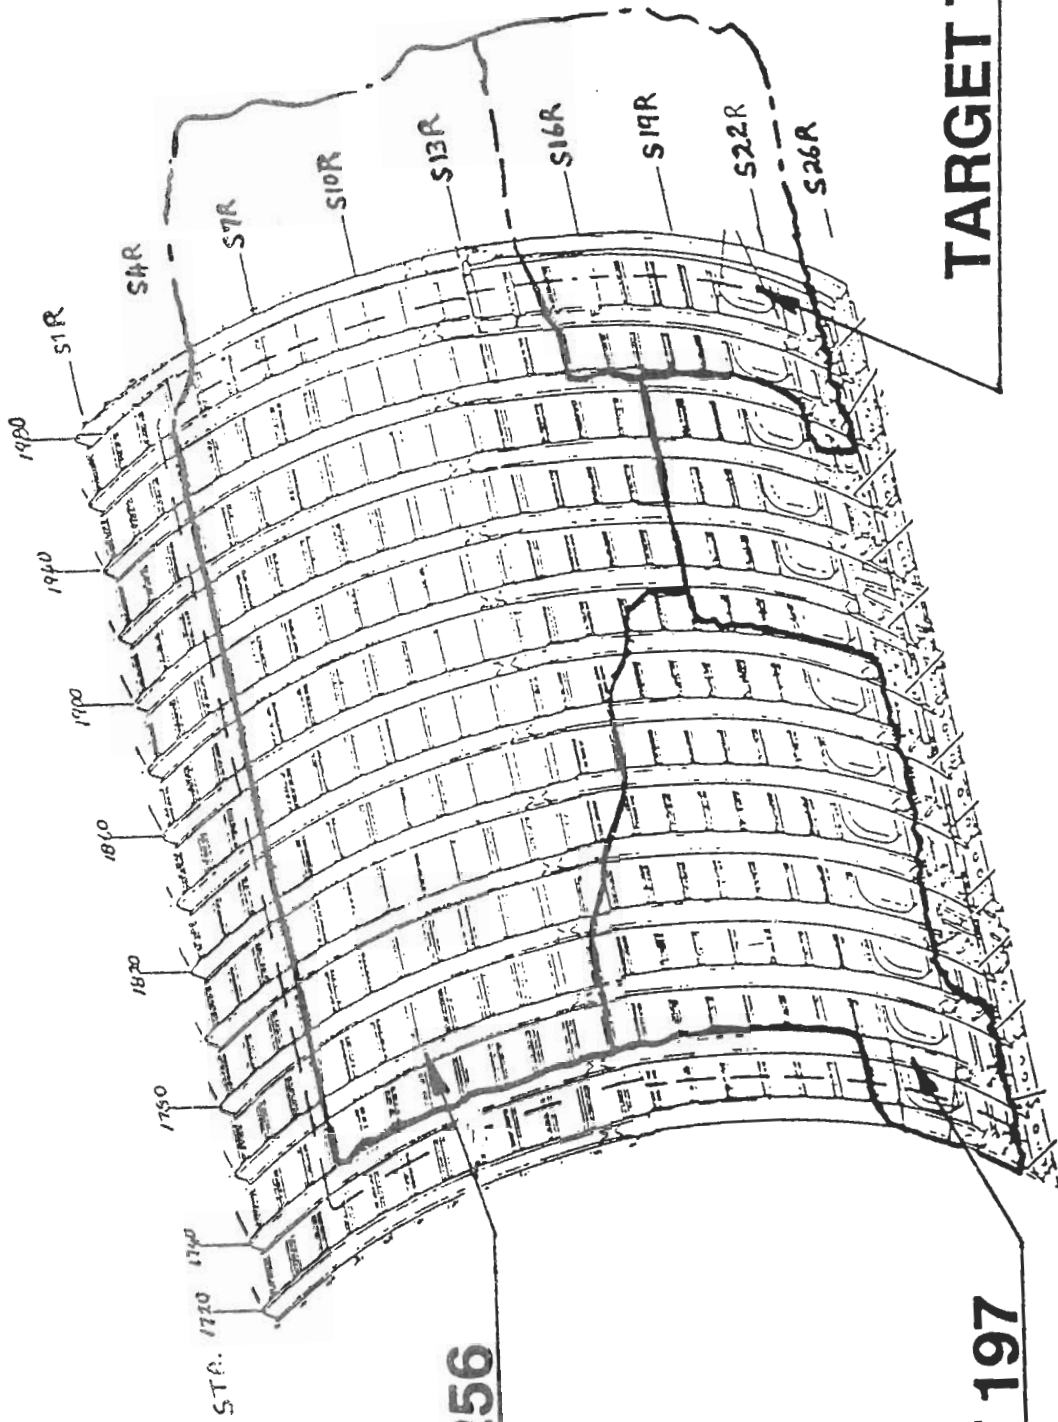
TARGET T 256

The structure fractured at body stations 1960 and 2200 and at stringers 5R and 8L. It showed evidence of heavy smoke deposits on the inner surface and heat discolouration of the paint on both the inner and outer surfaces. Deformation of the structure through impact showed a twist due to a high torsional load in a clockwise direction. This deformation is consistent with the mode in which Target 256 fractured at body station 1740.

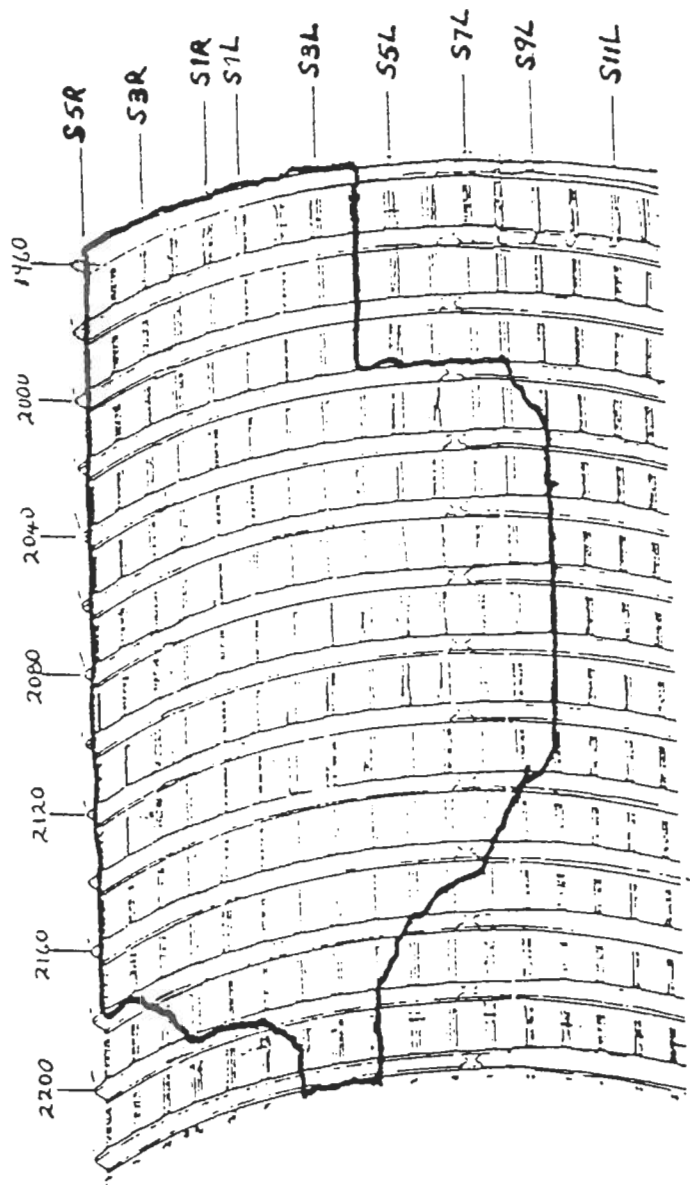
TARGET T 267

The structure fractured at body stations 1720 and 2000 and extends from below cabin floor level to stringer 1R. Severe heat damage was evident on the fuselage crown structure with signs of smoke deposits extending down to the upper main deck cargo door frame. A large section of the main deck cargo floor

is attached to the fuselage structure and deposits of molten material were noted between the 9G barrier net and pallet position PL. Several straps of the 9G barrier net, which were visible, showed some heat damage and signs of blue stains.

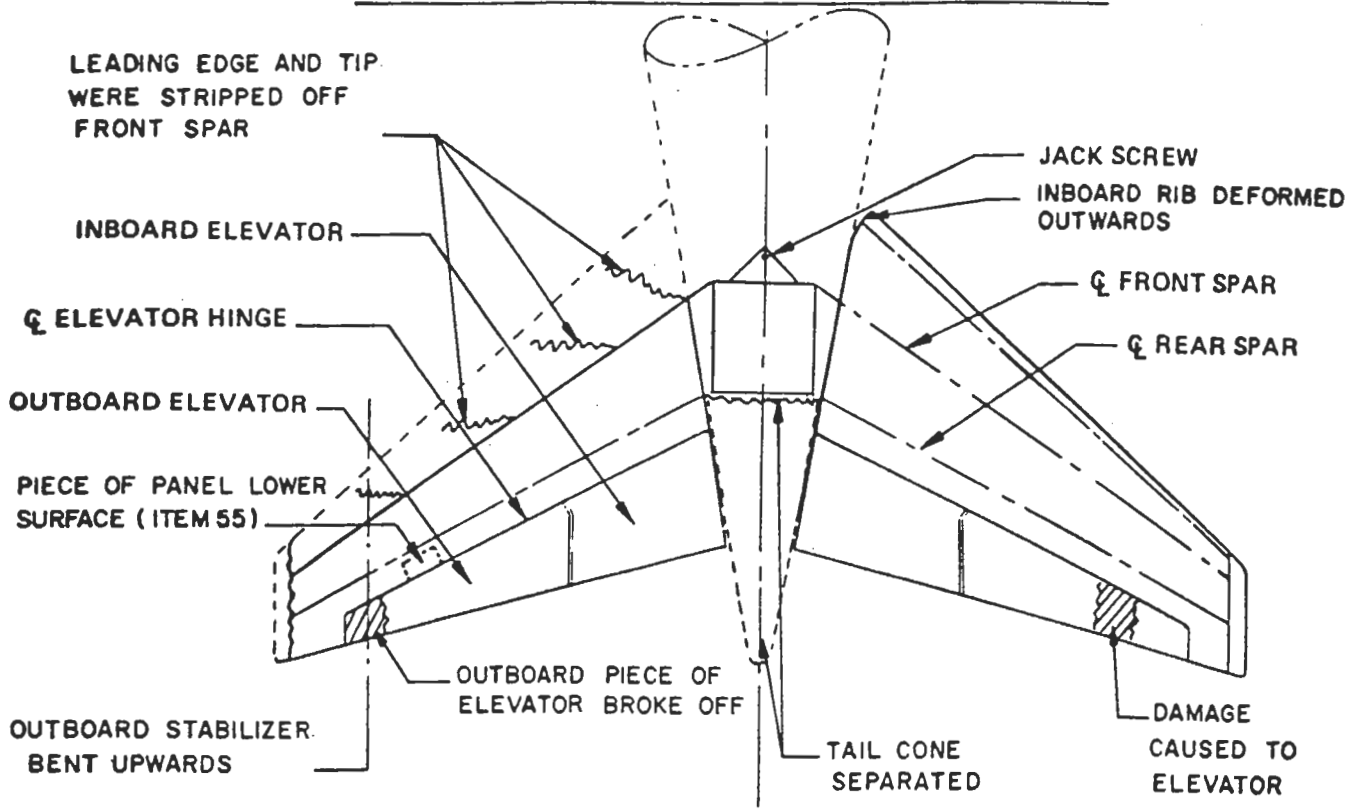
HORIZONTAL STABILIZER (TARGET T41)

The horizontal stabilizer was found to be complete with elevators attached. There was no evidence of heat or smoke deposits on the skin surfaces. The left stabilizer leading edge was detached from the front spar. The tip and adjacent structure were extensively damaged i.e. split and bent upwards. The outboard elevator tip was detached. It was observed that the stabilizer actuator jackscrew had sheared below the gimbal ball nut with four grooves protruding below the ball nut and nine grooves above. No distortion of the jackscrew was evident. The inboard rib at the

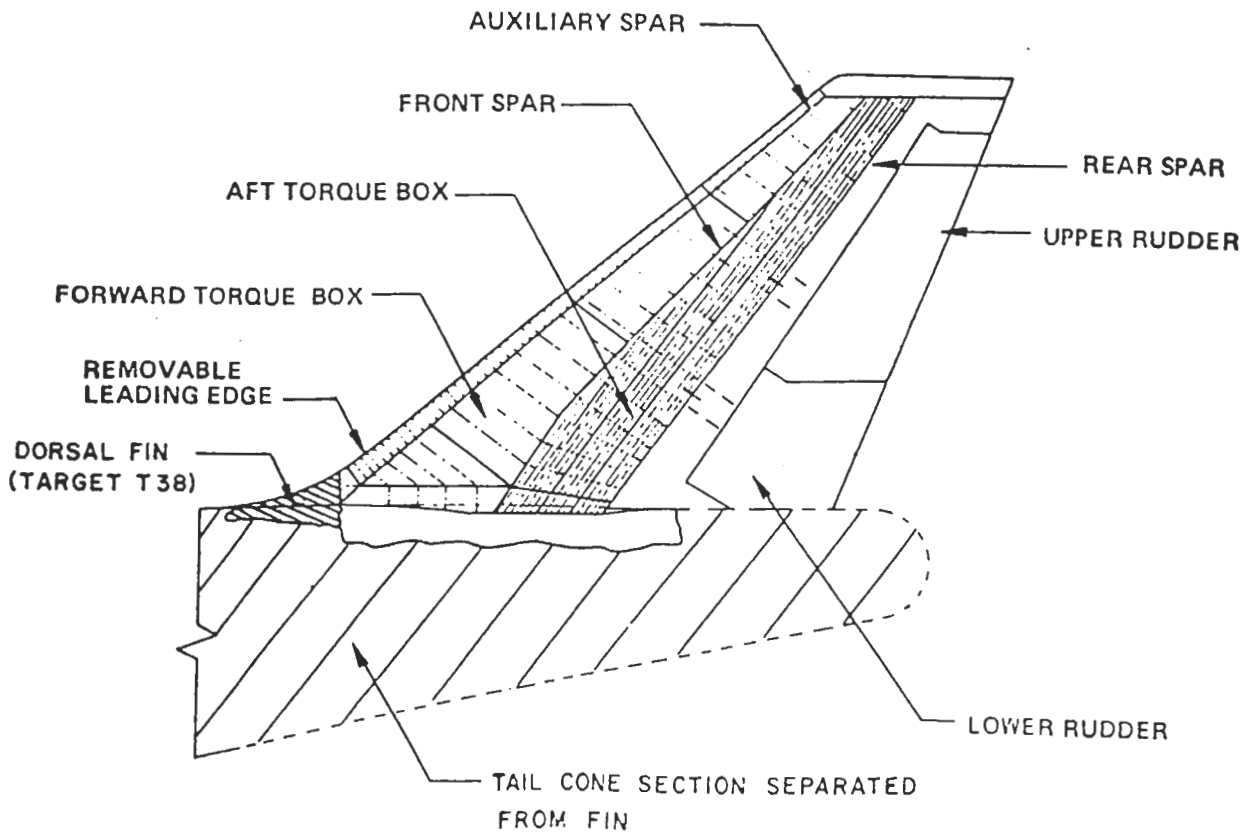
VERTICAL STABILIZER (TARGET T36)

The stabilizer was complete with both upper and lower rudders intact and a section of empennage structure remained attached to the base. There was no evidence of heat or smoke deposits on the outer surfaces and no significant impact damage was apparent.

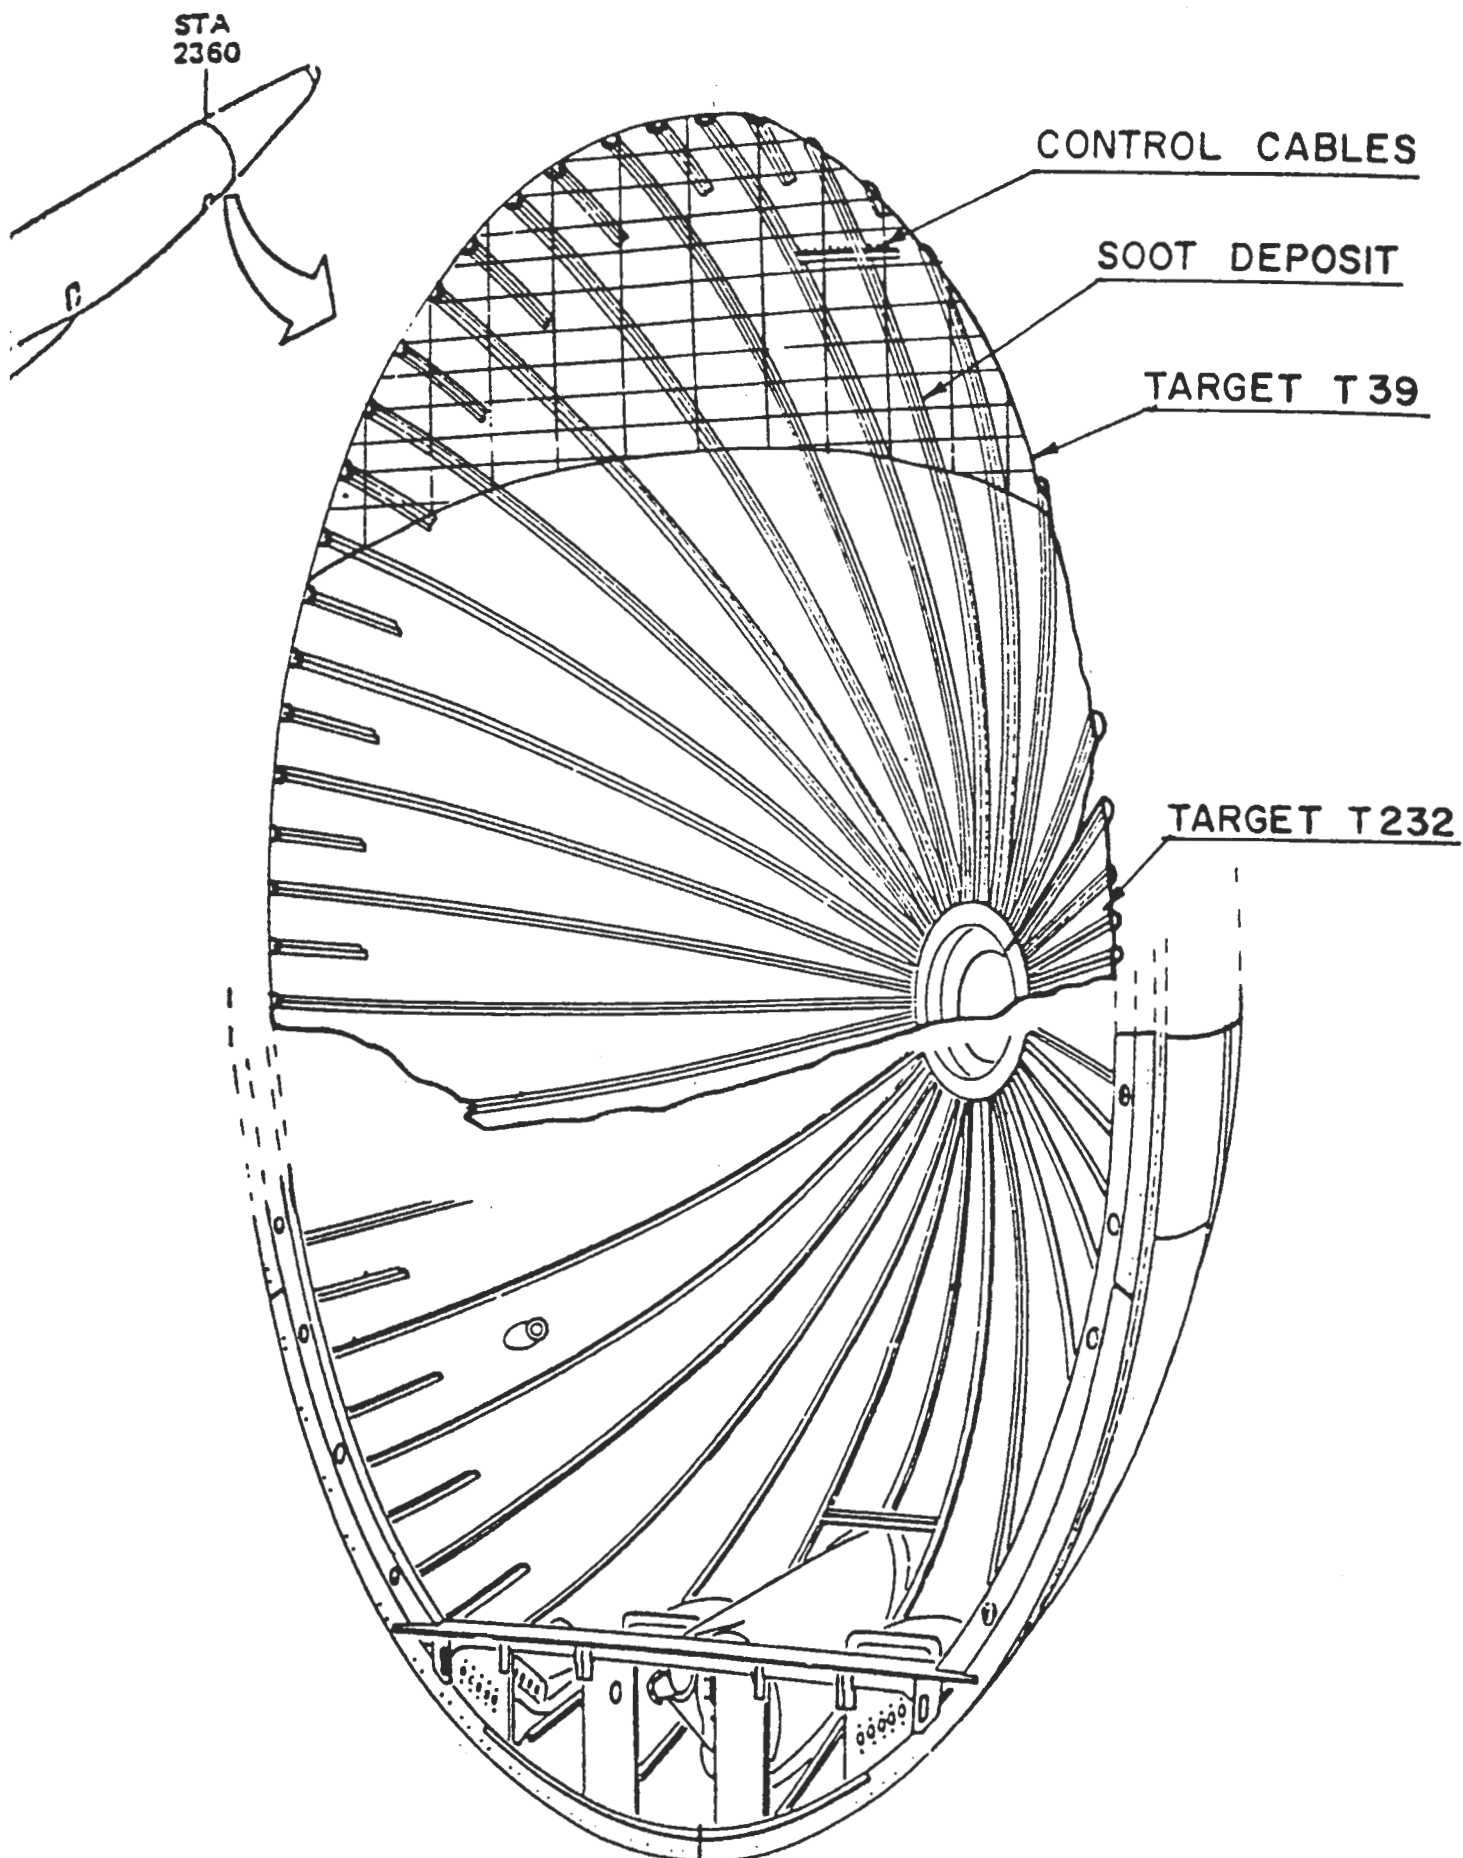
REAR PRESSURE BULKHEAD (RETRIEVED)

Heavy smoke deposits and heat discoloration were evident at the top centre sector location and all control cable aperture seals were damaged. There was evidence of light smoke deposits on the aft surface of the bulkhead.

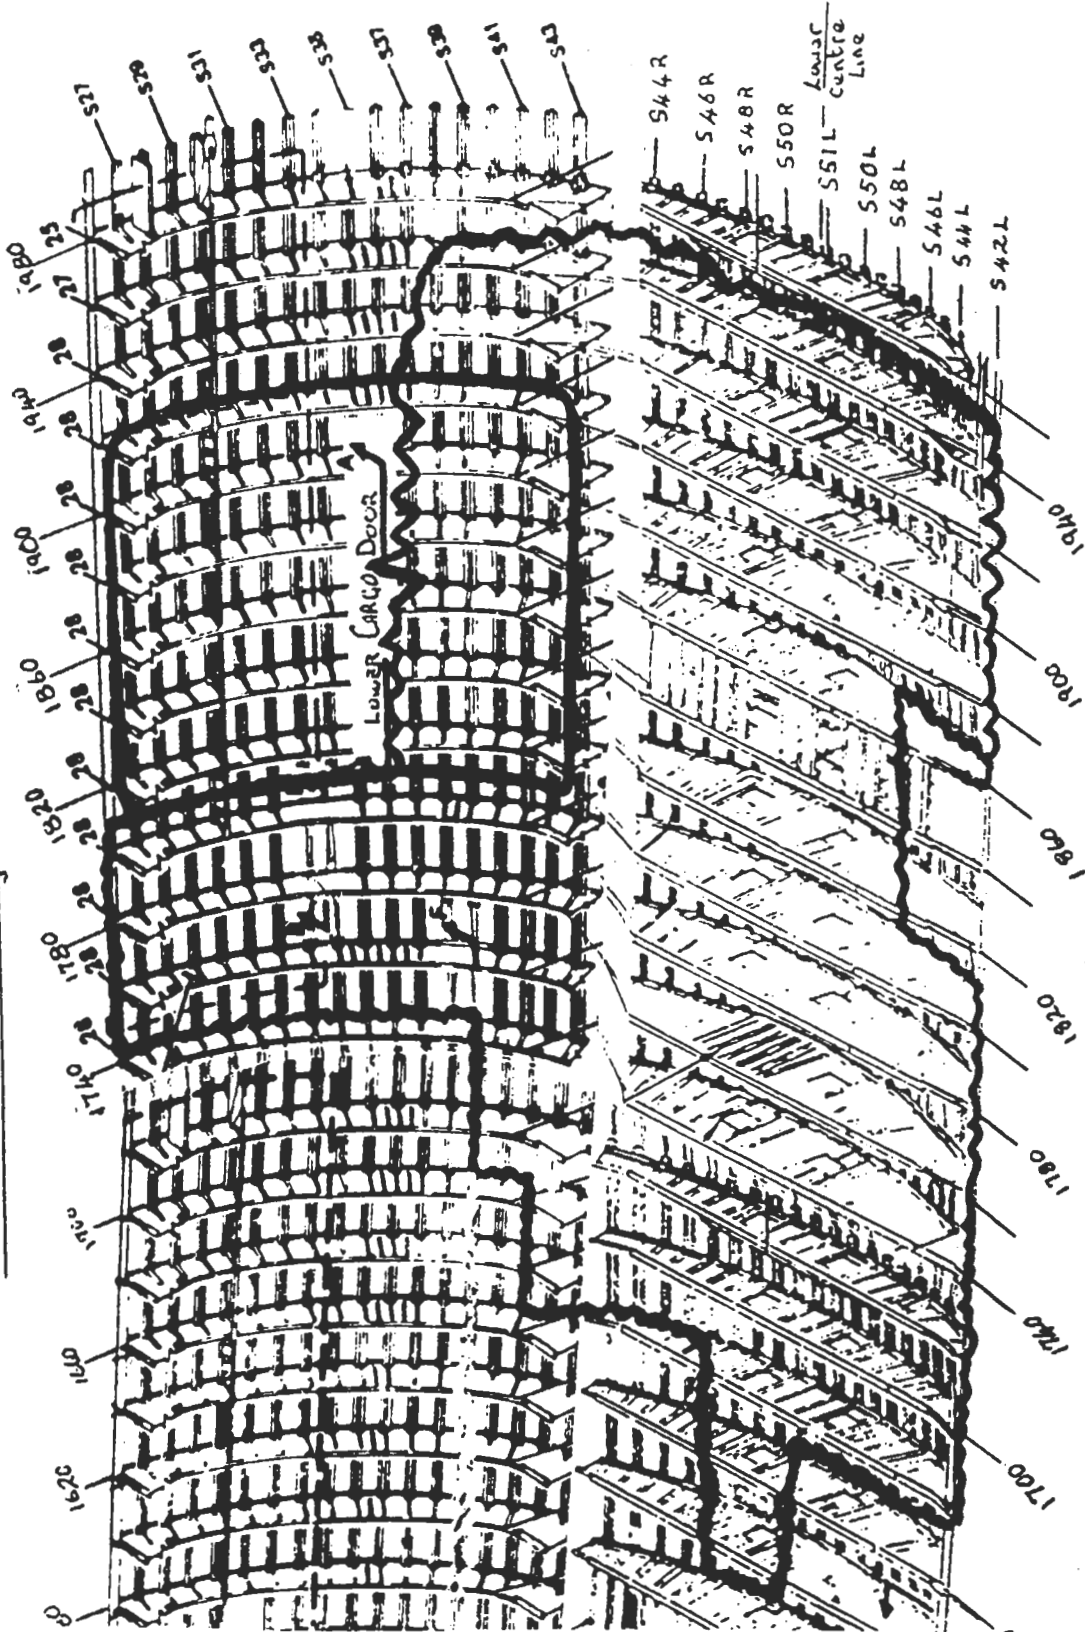
Target 244
Lower aft fuselage

No signs of heat exposure or smoke deposits were evident on the inner or outer surfaces. The structure showed evidence of water impact damage on the lower right side of the fuselage which is consistent with the impact damage observed on target 219. The lower section of the lower aft cargo door was still
